January 3, 2001
NSRP 0583
N3-96-2

THE NATIONAL SHIPBUILDING RESEARCH PROGRAM

Evaluation of New Surface Preparation and Coating Repair Techniques in Ballast Tanks - Phase IV

**EVALUATION OF
NEW SURFACE PREPARATION AND COATING REPAIR
TECHNIQUES IN BALLAST TANKS-PHASE IV
TWENTY YEARS OF BALLAST TANK COATING SYSTEM TESTING**

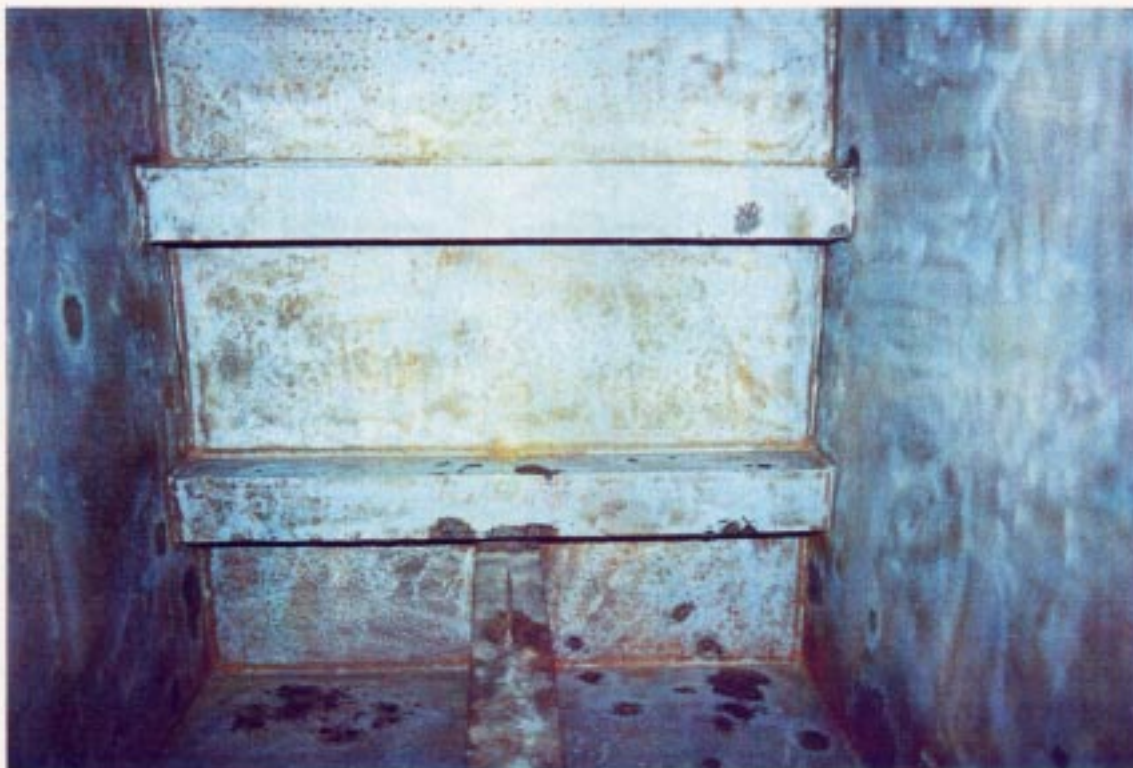
PHOTOGRAPH 3- REPAIR SURFACE PREPARATION TO MIL-P-24441

Photograph 3 shows the repair surface preparation of the Mil-P-24441 system prior to spot priming and full refresher topcoat application.

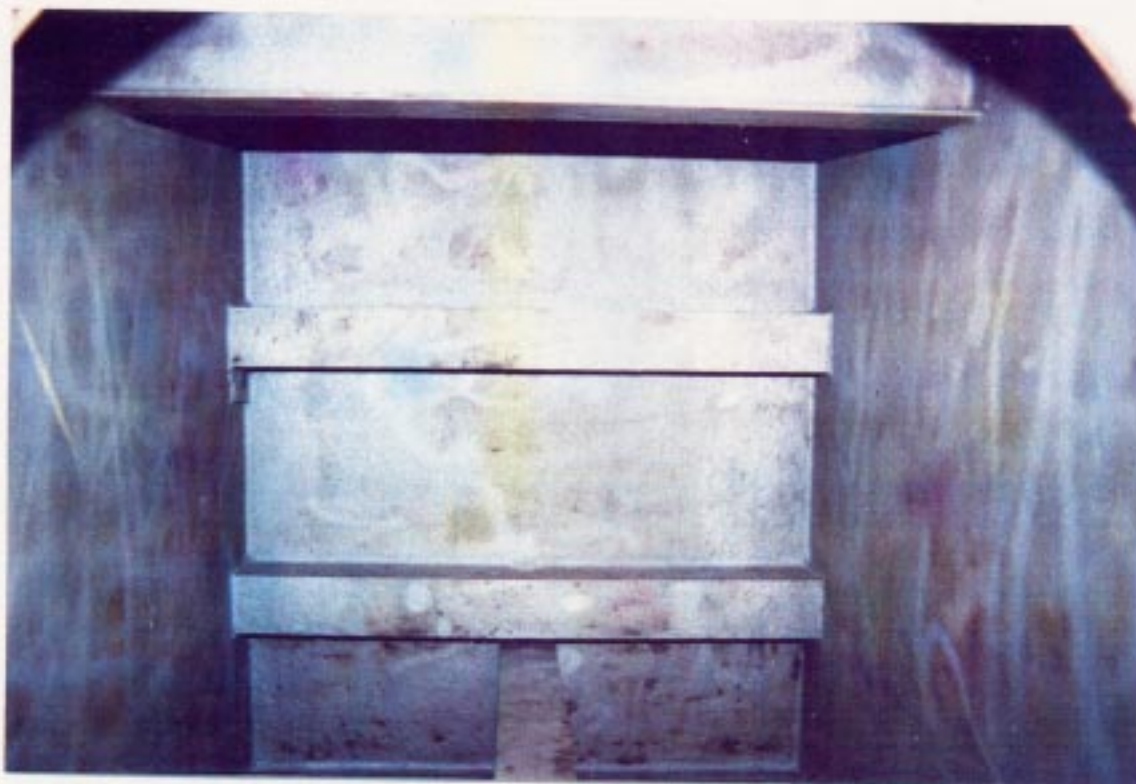
PHOTOGRAPH 4- NEAR WHITE CLEANED SURFACE SHOWING FLASH RUST

The chloride levels were determined to be 5 milligrams per square meter for Near White Blast Cleaned surfaces. This may seem low, based on the fact that the surface preparation flash rusted in a less than four hours; but may be due to the limitation of the swab technique used to determine chloride contamination. Sodium chloride salts bound up as ferric or ferrous chloride and combined with other complex salts could have influenced the solubility of the salts removed. After allowing the solution to set for three hours, the conductance of the solution increased resulting in a revised reading of 15 milligrams per square meter.

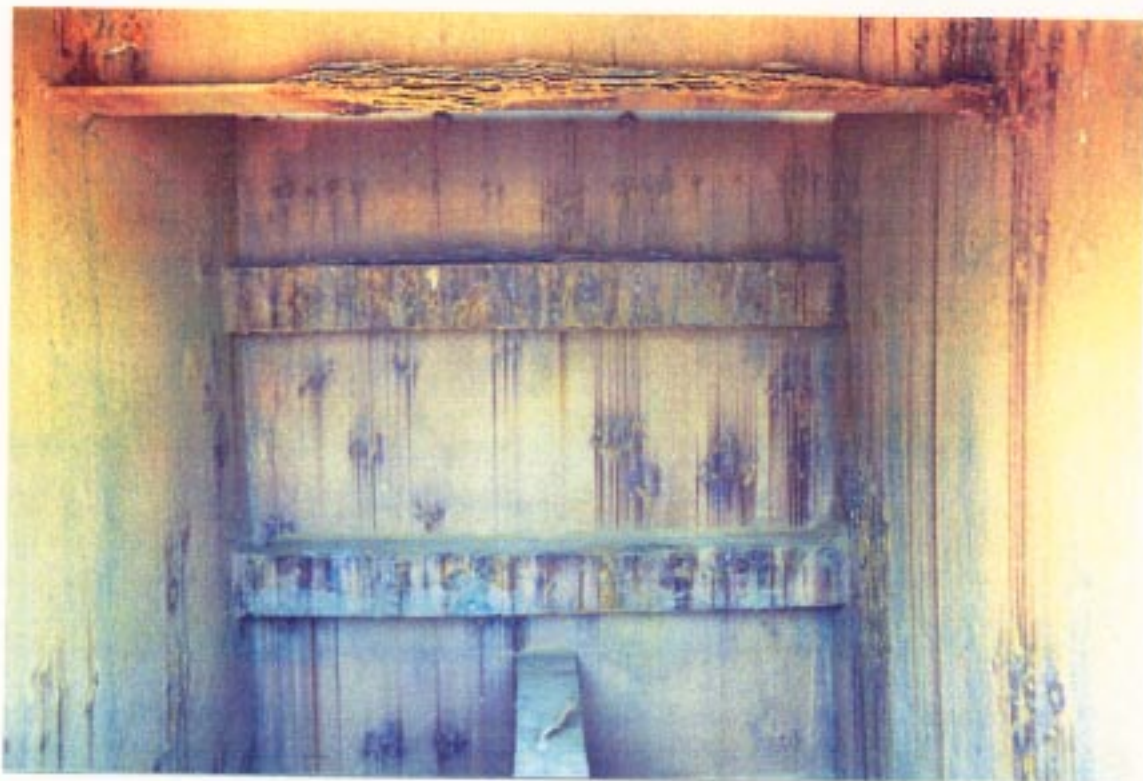
PHOTOGRAPH 6-SURFACE TOLERANT EPOXY A OVER HAND TOOL CLEANED SURFACE

use of power tool cleaning in lieu of abrasive blasting. This is especially true since, after five years of testing (two additional years), the performance of the two systems reversed and the hand tool cleaned tank was graded to be a Rust Grade 4, Failure – requiring replacement. The abrasive sweep blast cleaned (SSPC SP-7) tank was a Rust Grade 6. See Photographs 6 and 7.

From the ultrasonic thickness readings after twenty years, Tank One (Surface Tolerant Epoxy “A” over hand tool cleaned substrate) had very little metal loss on the flats except for one area on the tank bottom. There was major reduction in section on one back stiffener. Tank Four (Surface Tolerant Epoxy “A” over sweep blast cleaned substrate) had more overall metal loss; however, not significantly different from the baseline data from the 1987 report. The original system in Tank Four was the pre-construction primer with aluminum anode, which failed in three years. Subtracting the present thickness readings from the baseline data for each tank, Tank One has an overall average metal loss of 0.006 inches or 6 mils. Tank Four has an overall metal loss of 17 mils. If the stiffening metal loss is not considered for Tank Four, there is no measurable difference after twenty years. Remember that the baseline data in 1987 only included flats.

Because the one system had failed, repairs were made to both systems, and the testing was reinitiated. The hand tool cleaned tank system was repaired using hand tool cleaning techniques. The sweep blast cleaned system was spot blasted to remove failed coatings and the balance of the surface was sweep blasted. After repair and re-exposure for an additional seven years, the sweep blast cleaned tank was superior. The hand tool tank was a Rust Grade 4.5, and the sweep blast cleaned tank was a Rust Grade 7.5. There was major edge breakdown on the top stiffener in the hand tool cleaned tank; however, overall, the Epoxy “A” coating system demonstrated relatively good edge protection.

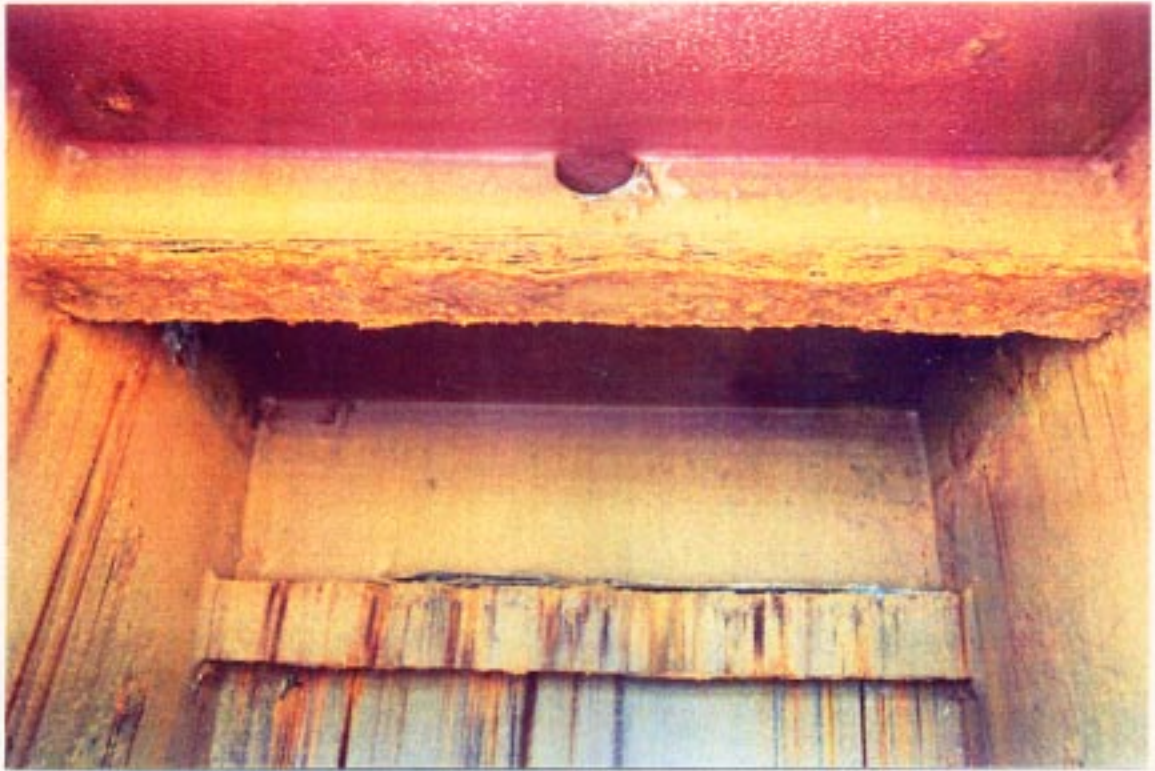
PHOTGRAPH 8- SURFACE TOLERANT EPOXY B

The Epoxy “B” coated tank has been under test for a total of fifteen years. See Photograph 8. Following the initial six years of testing, this system was beginning to show significant breakdown – Rust Grade 2. The top of the tank had twenty-five to fifty percent failures. The right side of the tank had totally failed. The balance of the tank had between five and ten percent failure.

After seven additional years of testing (fifteen totals), the top overhead and top back stiffener have major edge breakdown. The right side, lower left quadrant has also failed. This is an interesting observation in that no matter which coating system has been applied to this tank, this exact location fails during each test project. The reason for this unique failure is not known but it is believed that microbiological influenced corrosion (MIC) may be the cause.

The system was repaired using hand tool cleaning (SSPC-SP 2). After another two years of testing (eight years total), the overall failure was less than one percent with only minor breakdown on the edges of the overhead stiffener. No failure was observed on the balance of the structure. The coating system was again spot repaired at this time using hand tool cleaning.

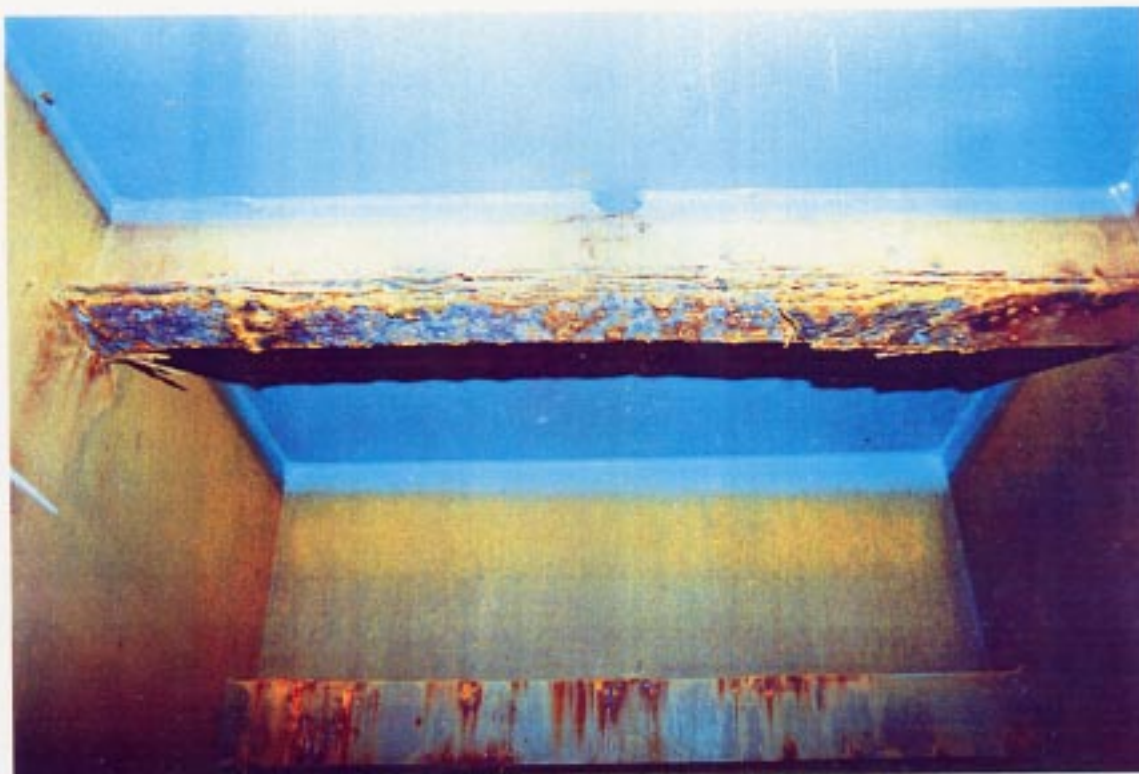
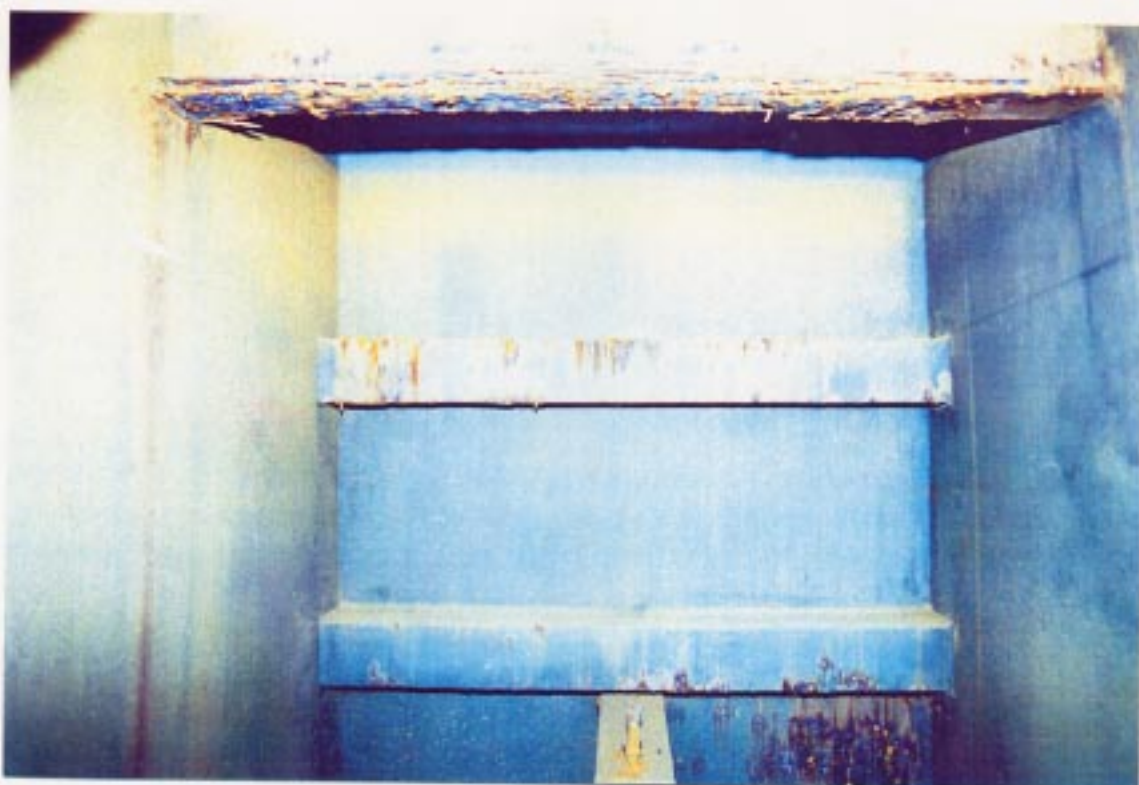
PHOTOGRAPH 9- MIL-P-24441

- The VOC compliant version of MIL-P-24441, Type IV (Formula 150/151) provided acceptable corrosion protection to the flat areas for twelve years with interim repairs made at five years; however, the system has total edge failure at the end of the test

period. Initial edge failure was reported at the end of three years. Mil-P-24441 also demonstrated surface tolerance to substandard surface preparation.

At the end of the first five years of testing, the Mil-P-24441 was still providing adequate protection except for failure of the sharp edges of stiffeners, especially the top stiffener, which had major reduction in section due to exfoliation. Again at the conclusion of twelve year, the system is providing good protection to the flats but has totally failed on the sharp edges. This corresponds with the service experience of the US Navy, which has lead to a program of developing edge retention lining systems. See Photograph 9.

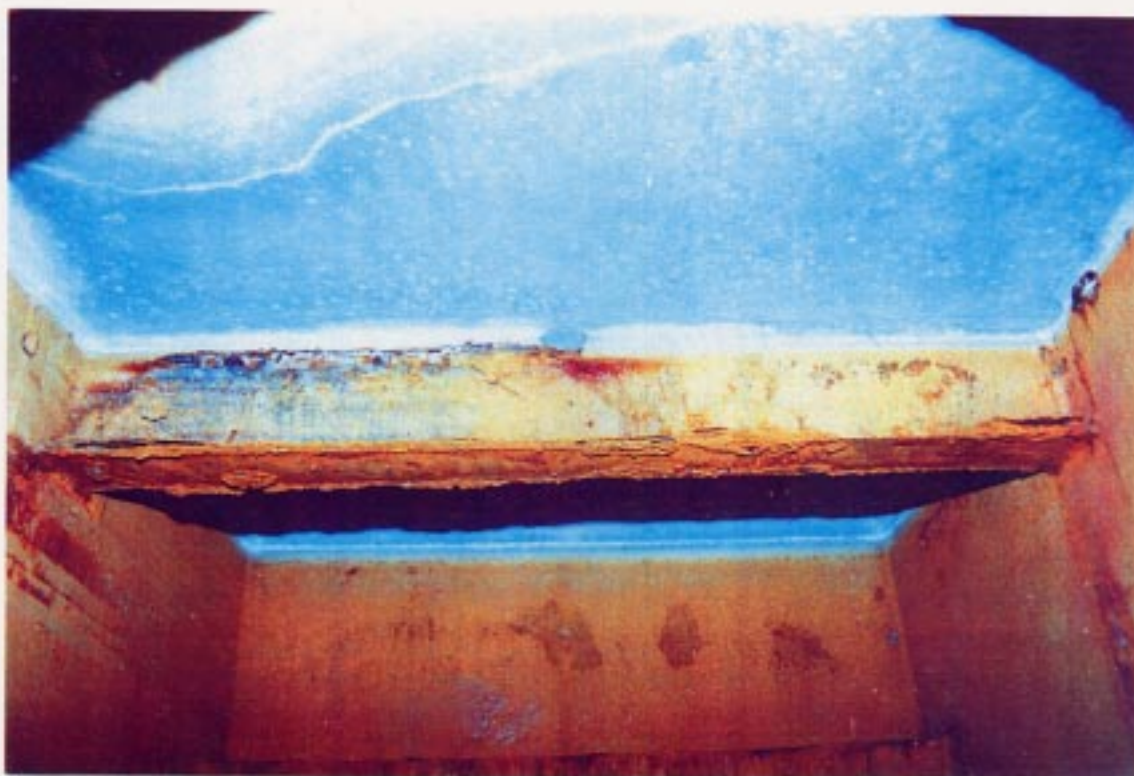
PHOTOGRAPH 14- HIGH RATIO WATERBORNE INORGANIC ZINC

- The waterborne, high ratio inorganic zinc failed after eight years. This system did not demonstrate compatibility with the salt contaminated substrate.
